Technical Assistance Leak Detection

California Rural Water Association

Water System

Frazier Park Public Utility District Jonnie Allison 4020 Park Drive 93225 661-245-3734 System #1510007/AR# 5406

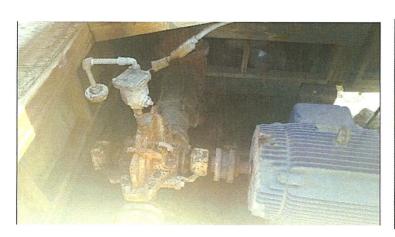
Water System Pictures

Comments: Frazier Park Public Utility District was established in 1939. The district is at about a 20% water loss to date. The district is mainly on steel pipes except for a section of PVC. Water Meters in district are old and outdated which is an water loss issue due to inaccurate reads. The district has Twelve Water Storage tanks in which two of them are leaking. Each of the two leaking tanks has Calcium deposits on outer tank. Both Harrison and Wolfe Booster pumps are outdated and leaking. Wolfe 2 tank shut off valve is inoperable. Wells 4-5 are leaking at packing, shaft is not online and causing issues. Recommendations:

- 1. Infrastructure replacment of old outdated steel pipes and faulty valves.
- 2. Replace old outdated Water Meters with Preferred Provider Program Kamstupp Smart Meters to insure accurate reads.
- 3. Repair or replace leaking Water Storage Tanks Preferred Provider Program "Superior Tanks".
- 4. Repair or replace old outdated Booster Pumps.
- 5. Repair or replace inoperable shut off valve.
- 6. Recommend additional TA for Wells, and Water storage tank issues.
